## SERVICE PARTS LIST

## **RECALL NOTICE!** See back page for important safety information.

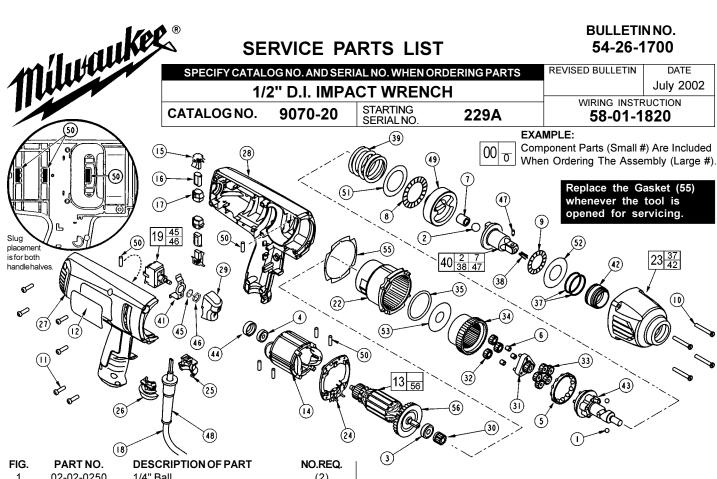
Torque to 45-50 in./lbs.

1	02-02-0250	1/4" Ball	(2)
2		1/2" Ball	(1)
3	02-04-0852	Ball Bearing	(1)
4	02-04-0645	Ball Bearing	(1)
5	02-40-0050	Angular Contact Bearing	(1)
6	02-50-3250	Unit Cage Bearing	(3)
7		Drawn Cup Bearing	(1)
8	02-80-0200	Thrust Bearing	(1)
9	02-80-3256	Thrust Bearing	(1)
10	05-88-5988	K50 x 35mm Screw	(4)
11	06-95-6290	M5 x 2.24 x 18 Plastite Screw	(6)
12	12-20-9070	Service Nameplate	(1)
13	16-10-0275	Armature	(1)
14	18-07-2275	Field	(1)
15	22-18-0040	Brush Assembly	(2)
16	22-20-0110	Brush Tube	(2)
17	22-20-0465	Brush Tube Holder	(2)
18	22-64-0970	Cord	(1)
19	23-66-1305	Switch	(1)
22	28-14-0175	Gearcase	(1)
23	14-38-0100	Front Housing Assembly	(1)
24	31-15-2045	Field Connector	(1)
25	31-17-0260	Cord Clamp	(1)
26	31-17-0270	Cord Clamp	(1)
27	31-44-2176	Right Handle	(1)
28	31-44-2181	Left Handle	(1)
29	31-92-0060	Rocker Trigger	(1)
30	32-60-0150	Sun Gear	(1)
31	32-60-0175	Sun Gear	(1)
32	32-62-0200	Planet Gear	(3)
33	32-62-0215	Planet Gear	(5)

34	32-65-0005	Ring Gear	(1)
35	34-40-0070	O-Ring	(1)
37		O-Ring	(2)
38	40-50-8320	Detent Spring	(1)
39	40-50-0241	Spring	(1)
40	14-73-0145	Anvil Assembly	(1)
41	42-36-0275	Switch Bracket	(1)

FIG.	PART NO.	DESCRIPTION OF PART	NO.REQ.
47	44-60-1170	Detent Pin	(1)
48	44-76-0210	Cord Protector	(1)
49	44-82-0205	Ram	(1)
50	45-30-0025	Rubber Slug	(6)
51	45-88-0535	Washer	(1)
52	45-88-1575	Washer	(1)
53	45-88-3260	Washer	(1)
55	43-44-0991	Gasket	(1)
56	22-84-0375	Fan	(1)

11 16	Torque to 25-30 in./lbs. At the time of brush replacement, the tool should be			
	relubricated with Type "Z" Grease, No.49-08-7655.			
FIG.	LUBRICATION (Type "Z" Grease, No.49-08-7655):			
23,34,42,	Lightly coat with grease the Ring Gear (34) and the			
43,49	bearing races of the Camshaft Planet Carrier (43), the			
	back bearing surface of the Ram (49) and the I.D. the			
	Front Housing Bushing (42).			
7,40	Place a dab of grease in the Needle Bearing (7) inside			
, -	the Anvil (40).			
31,32,33,43	Fill with grease the center of the five Planet Gears (33)			
	on the Camshaft Assembly (43). Fill the center of the
